COUNTIES (MD/PA) FREDERICK/ADAMS
M&D milestone no. 87 (90)
MHT-HSI no. F-6-36

FIELD SHEET: MASON & DIXON LINE, MARYLAND-PENNSYLVANIA BOUNDARY MARKER SURVEY

MASON & DIXON WEST LINE: MILESTONE 80 (90)

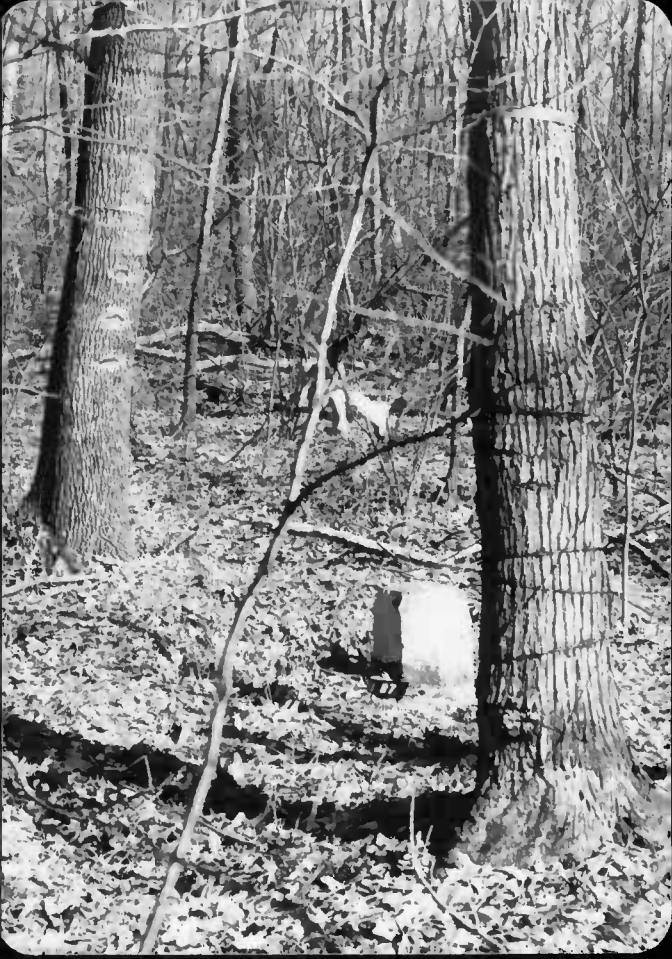
PHOTO: ALICE MARTIN 5/15/81 (981.11.5)

S face (MD): 11½" wide x 14" high; M & circle panel clear but badly scarred; most fluting & half of margins remain; chips all edges; mend evident

SE CORNER (M-)

ORIGINAL (1767)

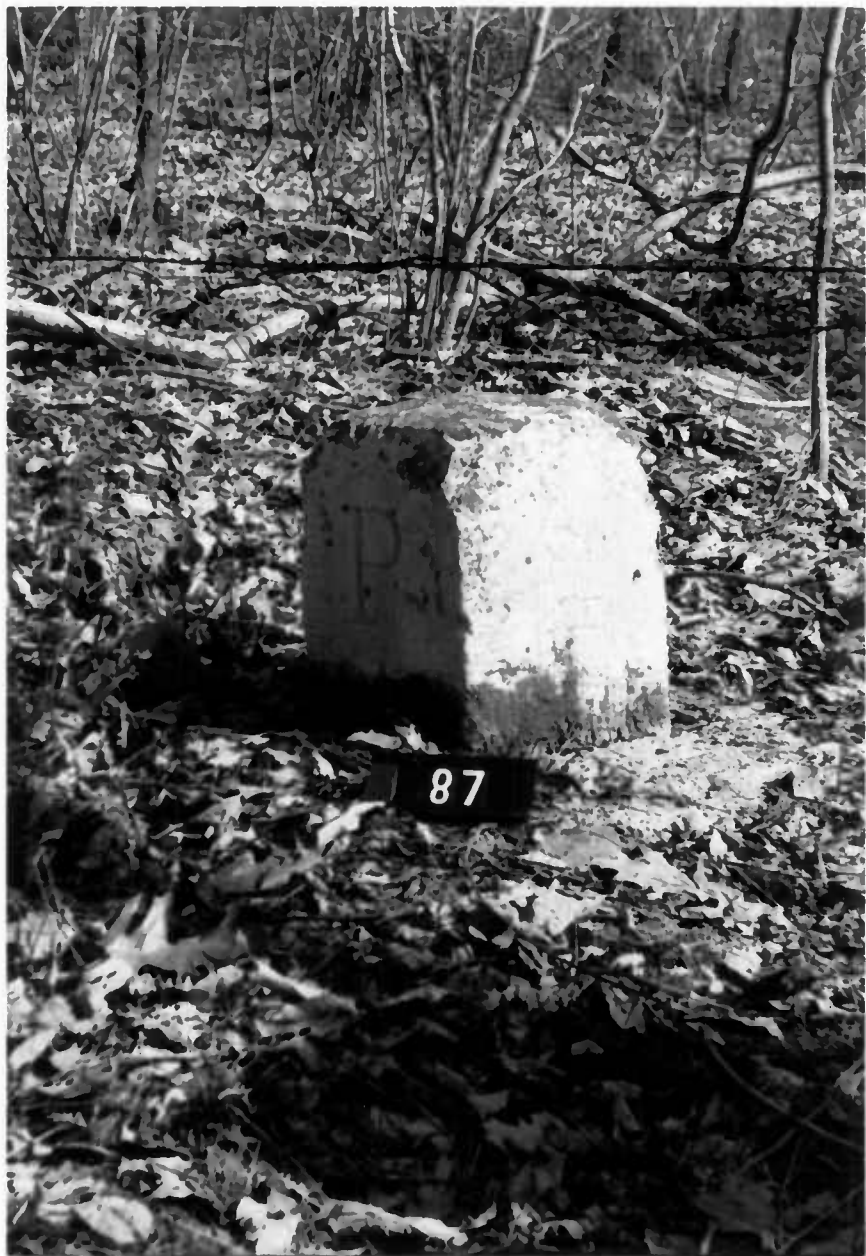
PHOTO: ALICE MARTIN 3/15/81
(1981. 11. 16)

NED WEST LINE: MILESTONE 87(90)
VIEW SE OF NW CORNER
OF STONE & SETTING
